Healthy Home Standard Report

21 Nov 2023 / 3/63 Norfolk Street, Ponsonby, Auckland / Ashish Haridas / HHSR001080

3/63 Norfolk Street, Ponsonby, Auckland

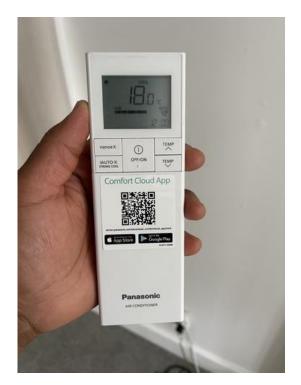
Photo 9

Panasonic heat pump- 6kW

Existing heat pump achieves at least 80% of the required heating capacity to Heat living area on property. Hence Compliant.

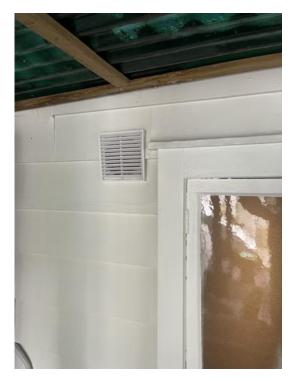
Photo 13

Is there a functional extraction fan or rangehood of exhaust capacity greater than 50 ℓ/s or an exhaust ducting have a diameter of more than 150 mm?

Yes

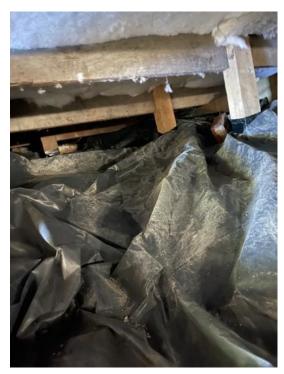
Photo 26

Is the underfloor space adequately ventilated with no obstructions for more than 50% of its perimeter?

No
