Property Condition Report

**51 Pompallier Estate Drive
Maunu
Whangarei District**

Client: Rhys Cortesi

Inspection Date: 4/03/2026

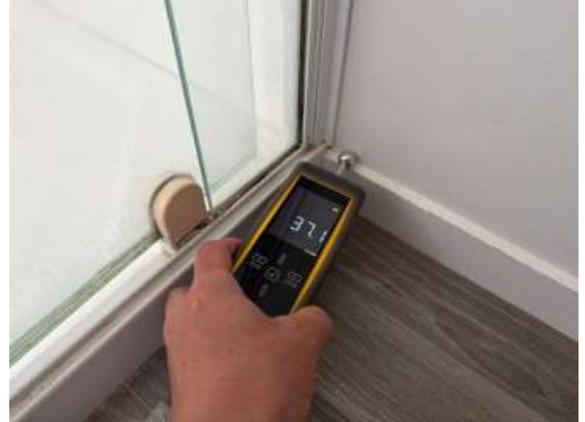
Moisture Readings:

Moisture readings taken at the shower/wall junction were below 40 digits at the time of inspection. Readings below 40 digits are considered to be dry for typical NZ conditions.

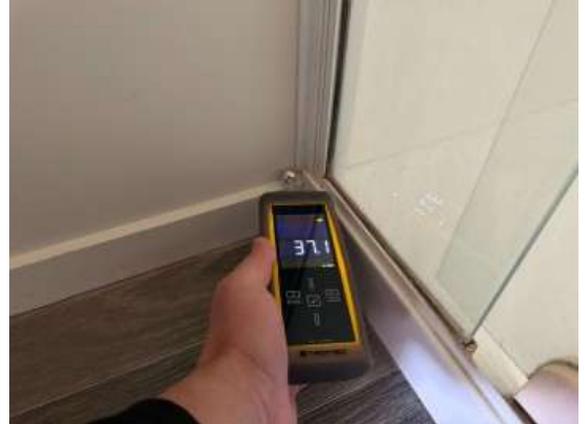
Moisture Readings:

Moisture readings taken at the shower/wall junction were below 40 digits at the time of inspection. Readings below 40 digits are considered to be dry for typical NZ conditions.
