Your Building Inspection Report

CONFIDENTIAL REPORT FOR
Mike Carle
ID 165135
Thursday, March 26, 2026

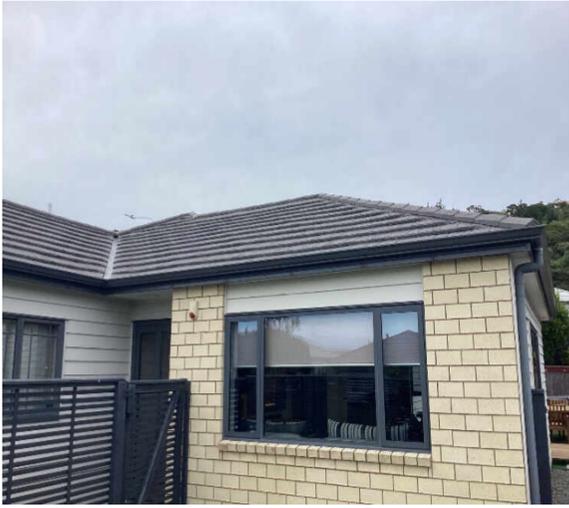
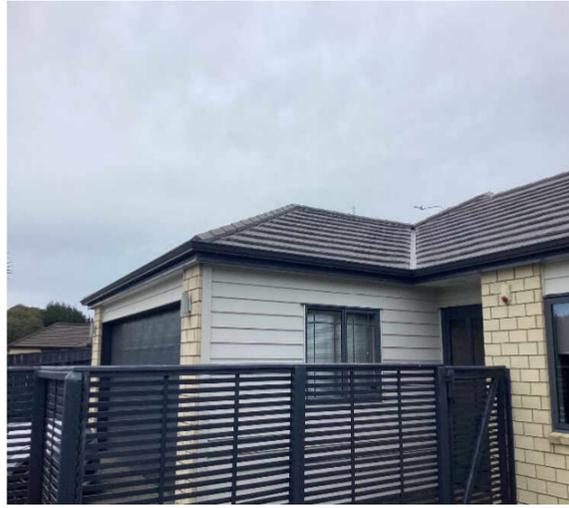
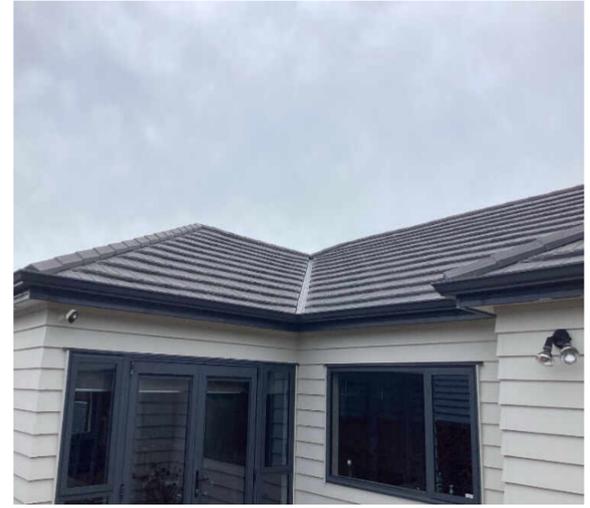
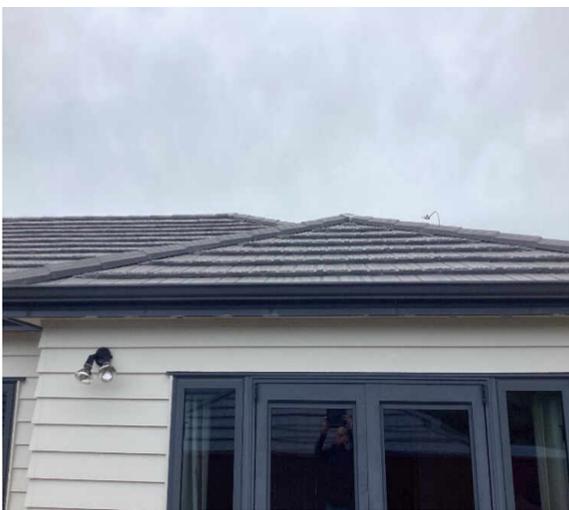
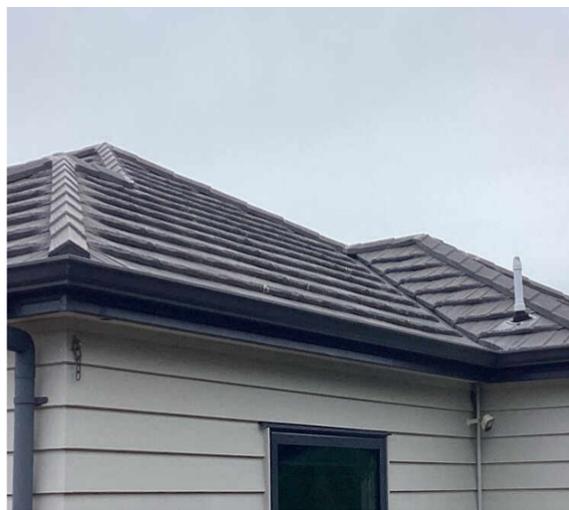
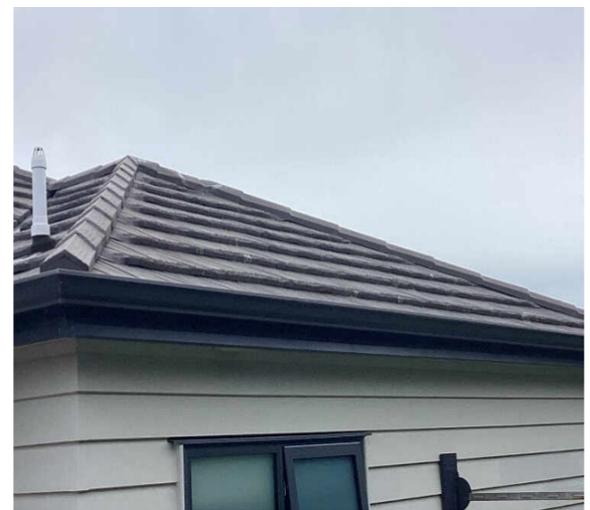
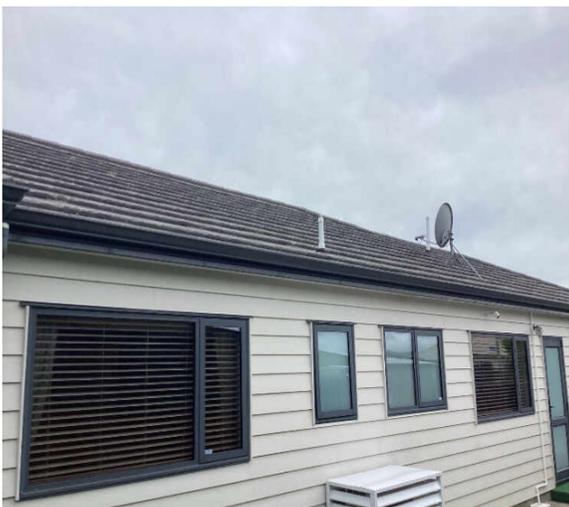
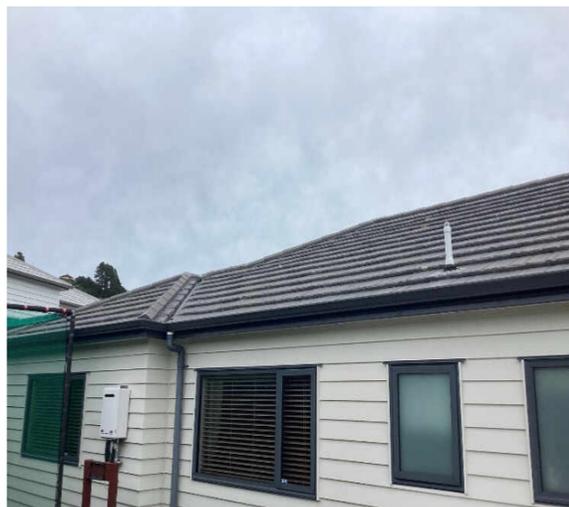
No visible issues noted during the inspection.

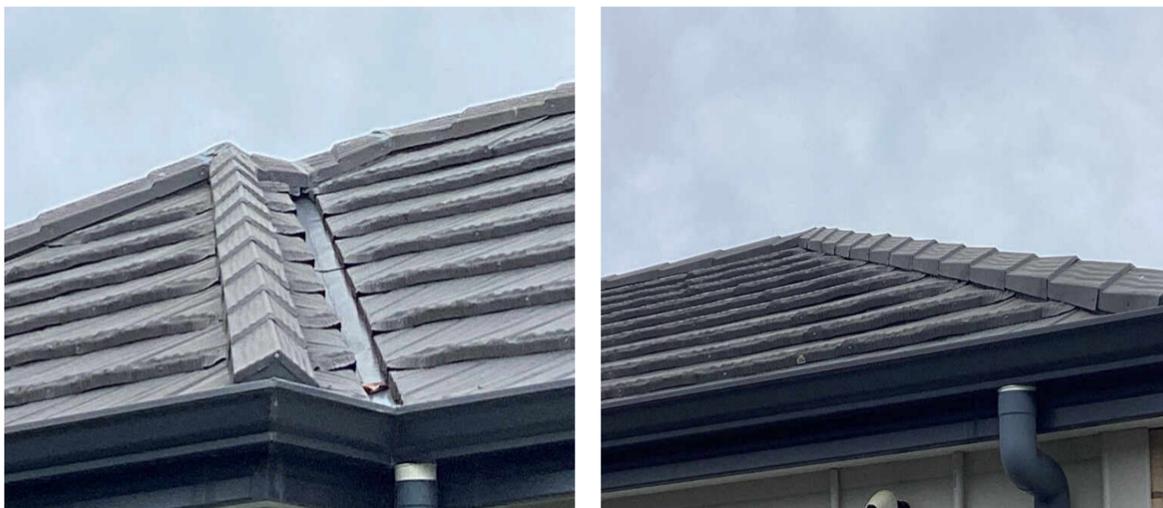
PREDOMINANT FLASHING MATERIAL (INCLUDING SIGNIFICANT MAINTENANCE)

No visible issues were noted during the inspection.

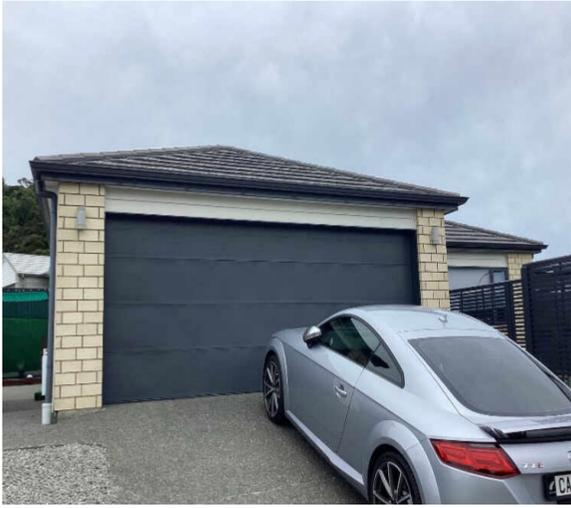
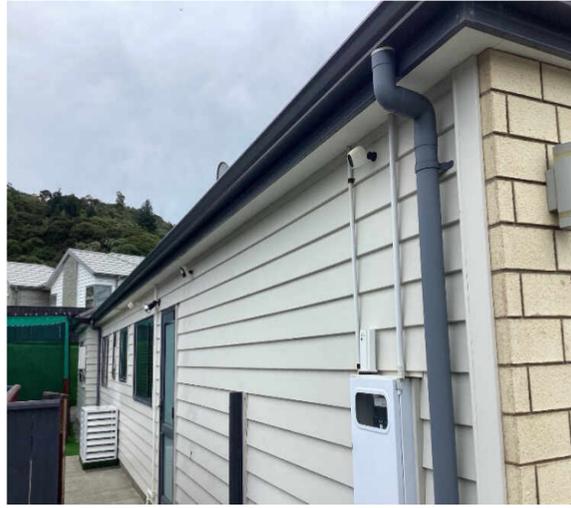
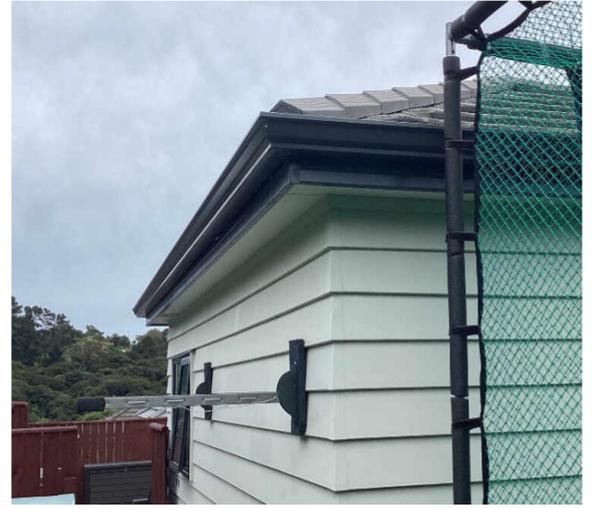
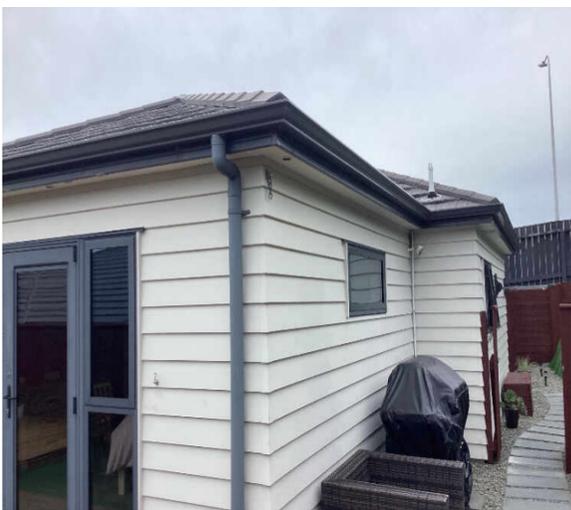
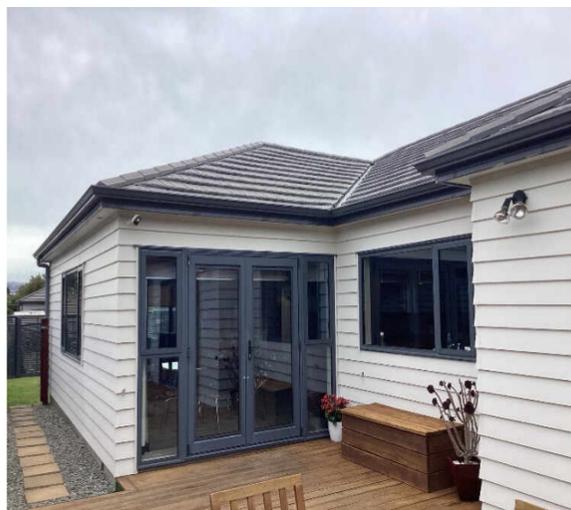
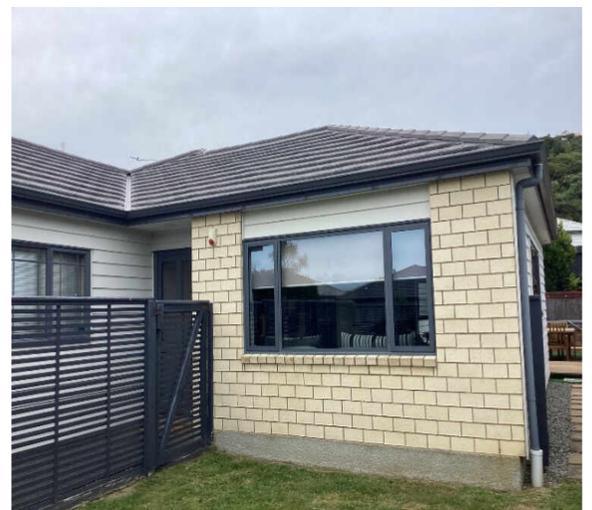
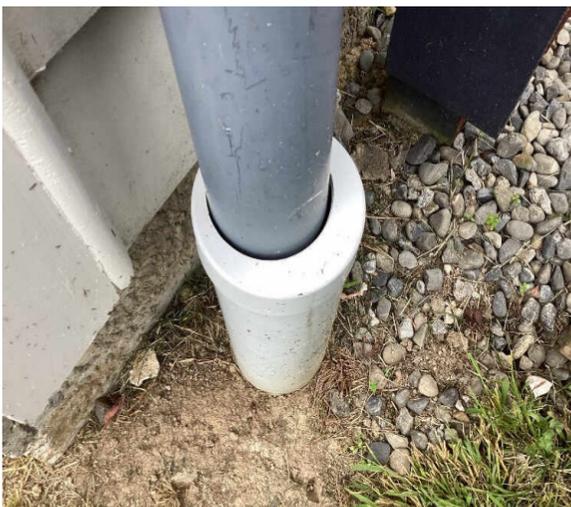
PREDOMINANT GUTTER & DOWNPIPE MATERIAL (INCLUDING SIGNIFICANT MAINTENANCE)

No visible issues were noted during the inspection.

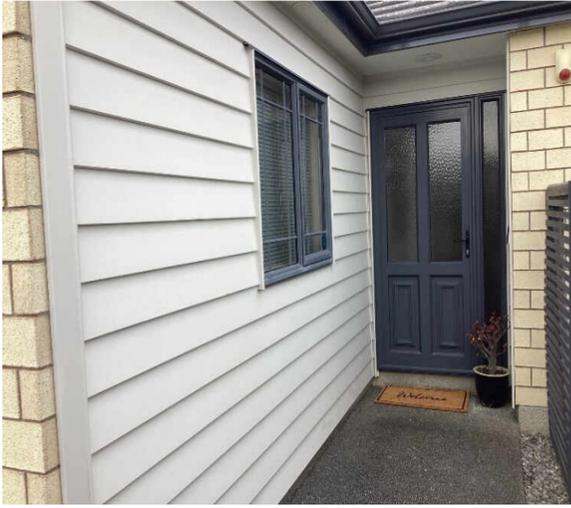
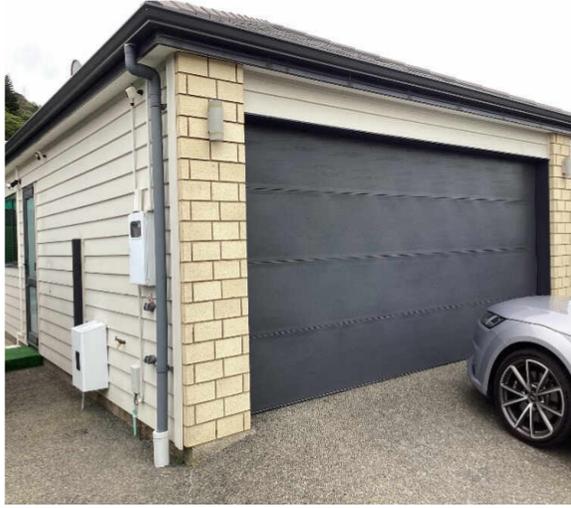
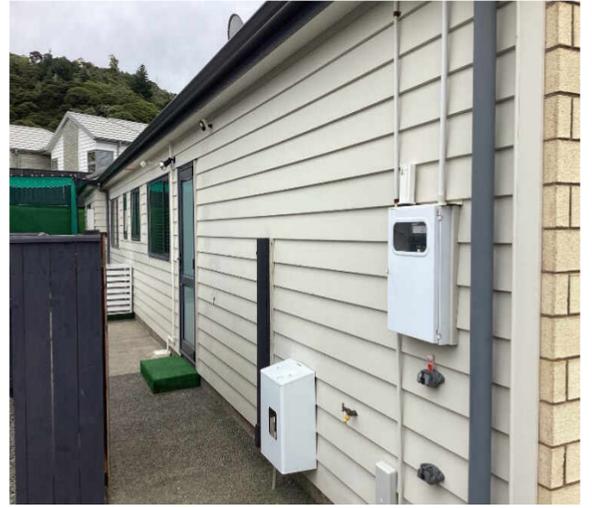
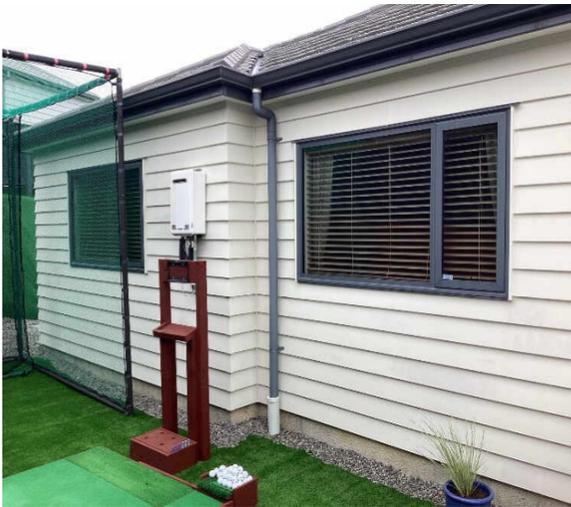
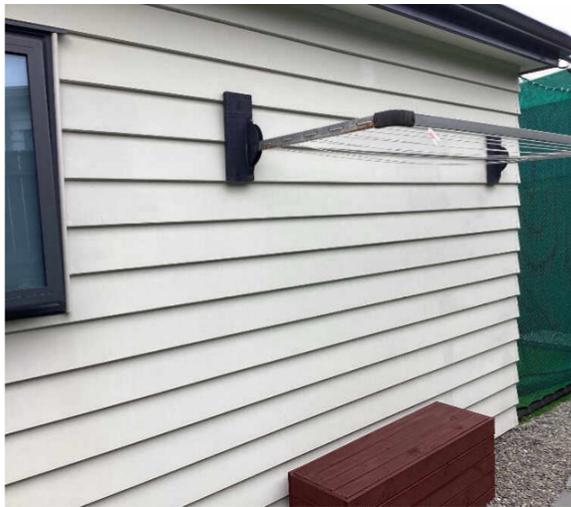
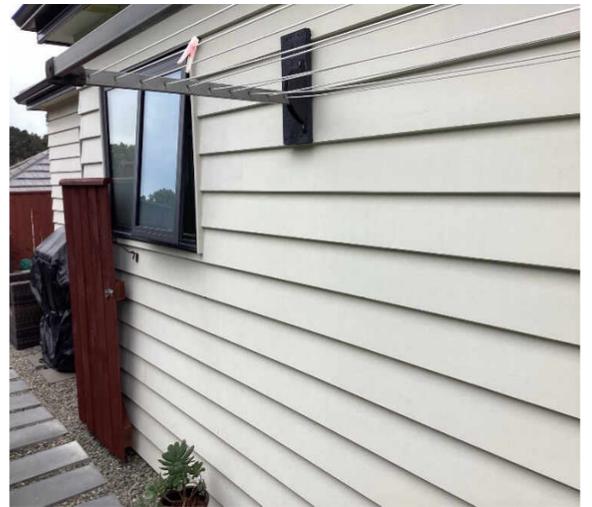
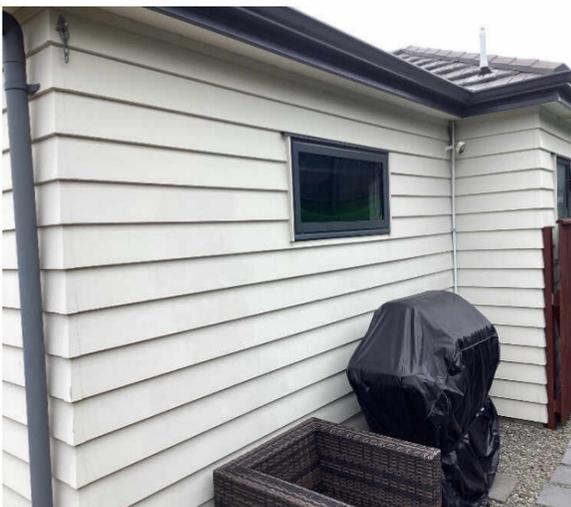
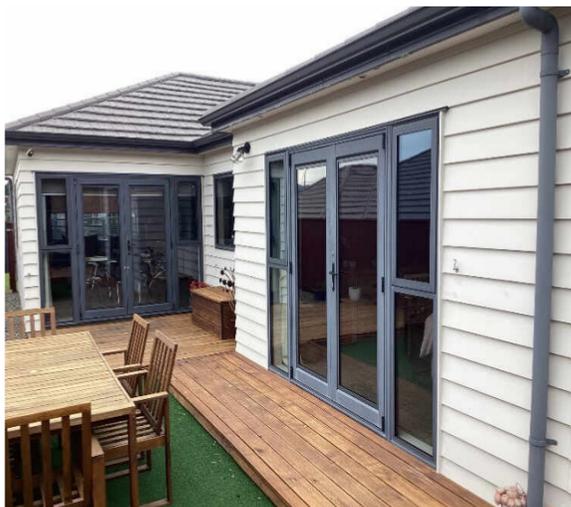
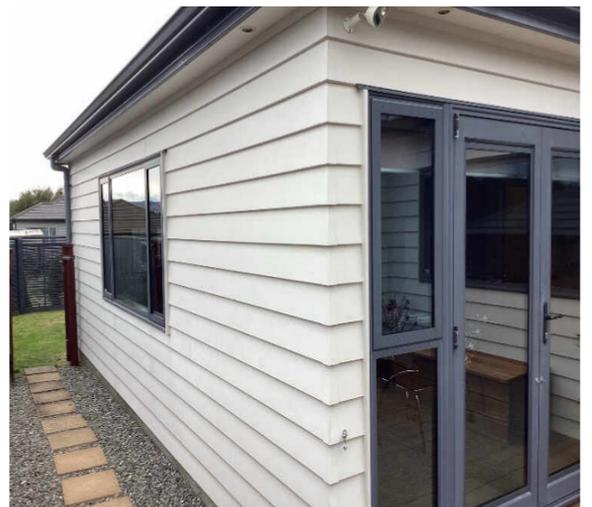
Brick veneer (note we cannot identify any defects behind the veneer). Fibre cement weatherboard (or similar material).

No visible issues were noted during the inspection.

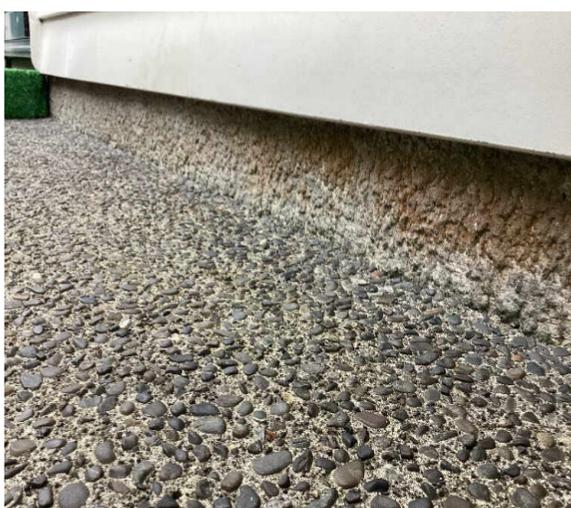
Due to the concrete slab there is no sub-floor space. We are unable to confirm the condition of the concrete slab or the soil beneath. For more detailed information and specification on the concrete floor slab we recommend that a search of the council building files be undertaken. No visible issues noted during the inspection.

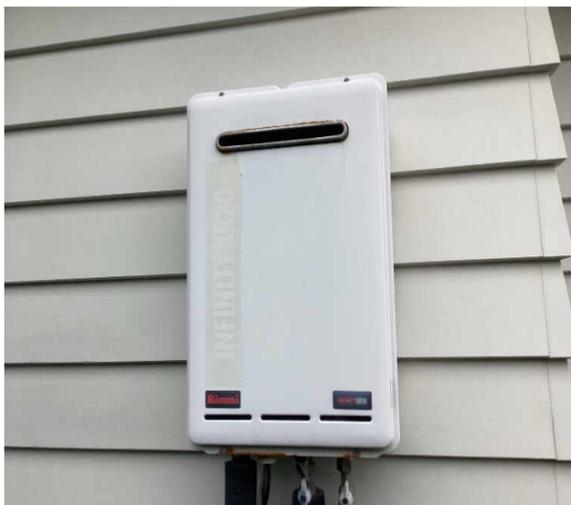
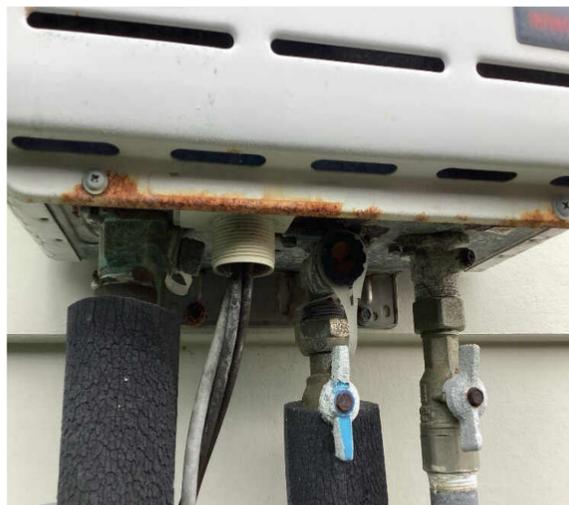
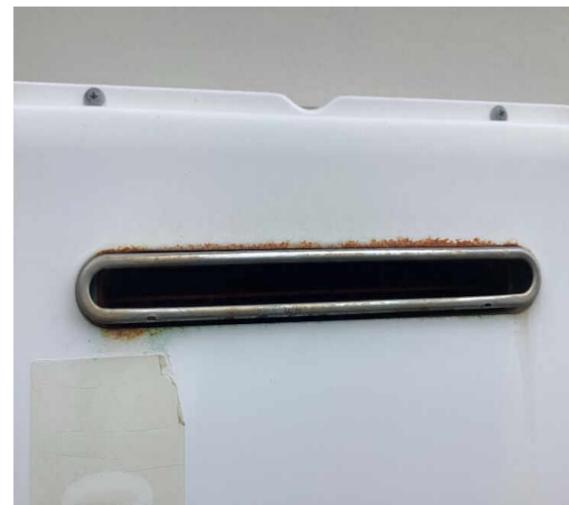
The average life span of this type of hotwater system is 10-12 years. This system is estimated to be older than this time frame. We suggest that a thorough examination is completed bi-annually (ideally at the end of winter and end of summer), and any pipe or cylinder breakdown, water pooling or any signs of deterioration should be investigated by a qualified plumber.

Corrosion to the casing will not affect functionality of the water heater but will continue to deteriorate over time. Allow for future replacement.

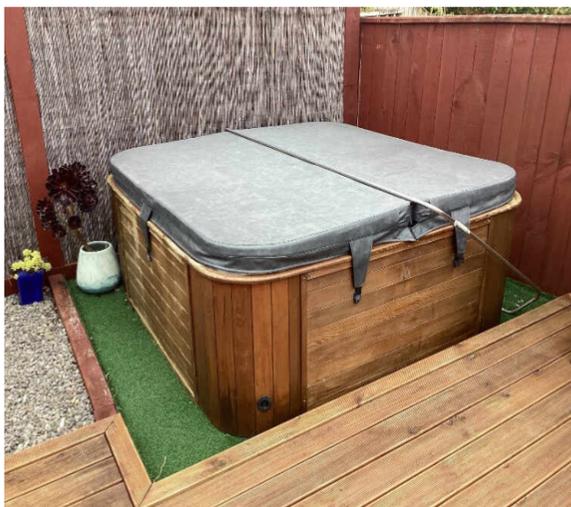
A swimming pool is present. This inspection specifically excludes any inspection of the pool, associated pool equipment and pool surrounds. An inspection should be made by a specialist pool inspector to determine the condition of the pool, pool equipment and surrounds.

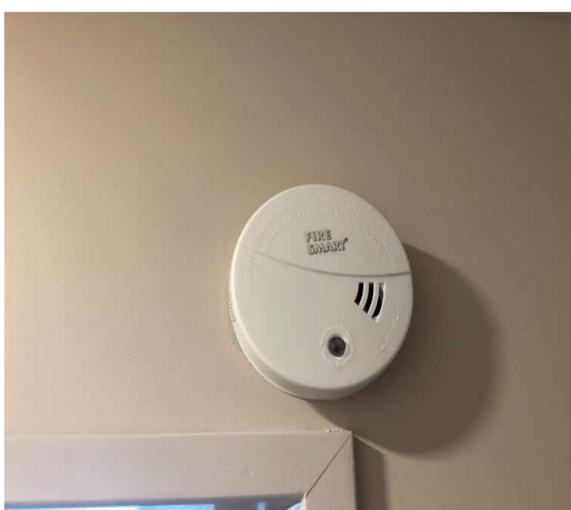
We recommend these are tested or replaced before moving into the property.
