# Your Building Inspection Report

CONFIDENTIAL REPORT FOR  
Brent Weber  
ID 147303  
Tuesday, May 06, 2025

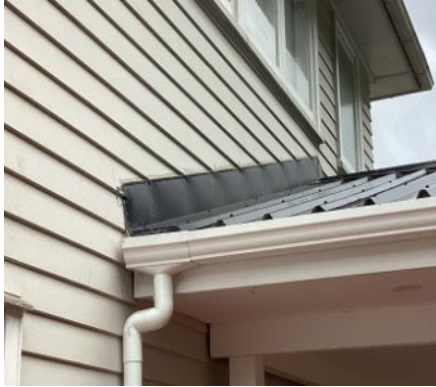
The apron flashings are surface mounted, so are completely reliant on sealant to prevent water ingress. Installations such as this do not provide a durable, long term waterproofing solution. The function of this cladding is to create mechanical overlap. Overlap is not achieved when flashings are installed outside the cladding.

The flashings need to be installed correctly, to prevent water ingress. This is an exterior shelter roof only, but water entering the structure wil cause damage.

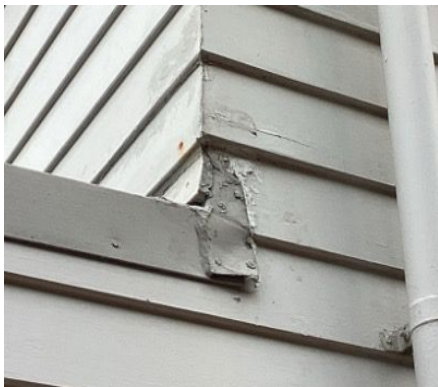
Some repair and repainting is required.

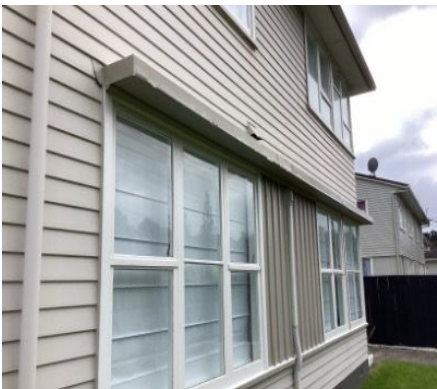
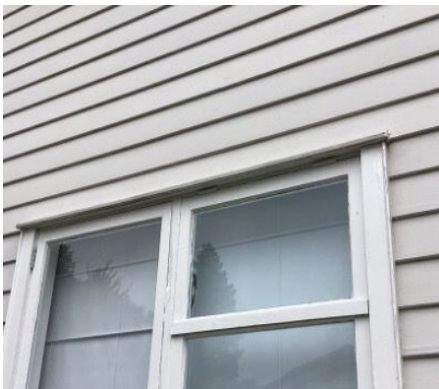
Some flashings are corroding. This may affect the integrity of the flashing. Allow for future replacement of corroded flashings.

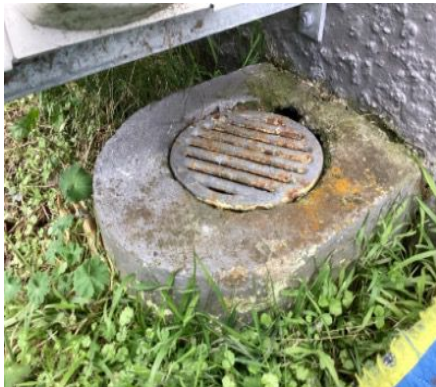
The waste pipes are made of clay. clay pipes are prone to leaking if settlement occurs. We recommend that the plumbing is visually inspected annually to check for leaks.

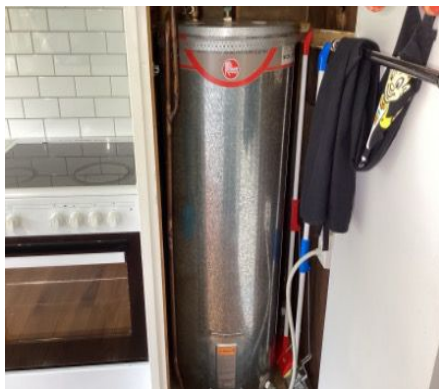
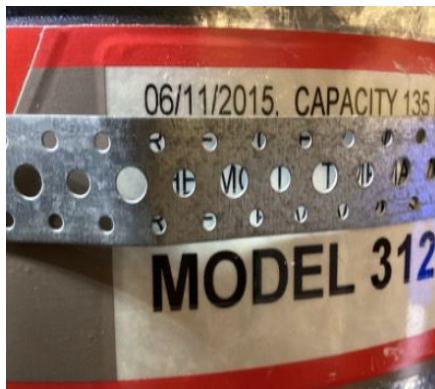
The average life span of this type of hotwater system is 10-12 years. This system is estimated to be older than this time frame. We suggest that a thorough examination is completed bi-annually (ideally at the end of winter and end of summer), and any pipe or cylinder breakdown, water pooling or any signs of deterioration should be investigated by a qualified plumber. No visible issues noted during the inspection. 2015

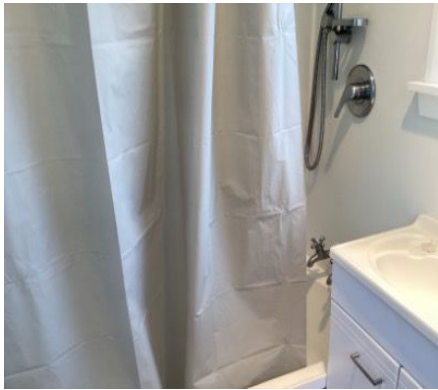
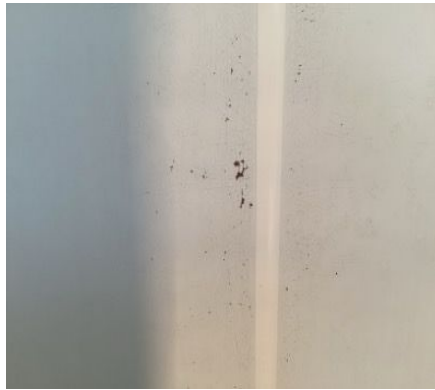
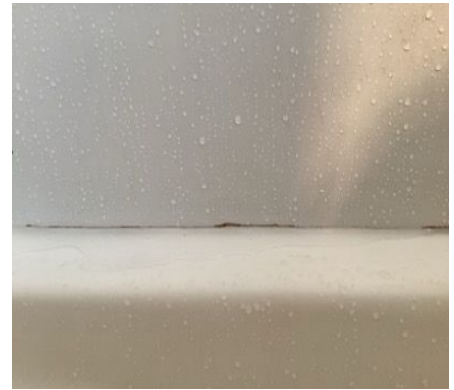
Shower over baths are prone to maintenance issues, failing and leaking where the wall linings meet the bath unit. Depending on the quality of the wall linings, sealant and the installation workmanship and how the bath has been maintained depends on how water tight it remains and how much future maintenance it will require. Moisture testing cannot be undertaken around the base or internal bath/shower linings due to inconsistencies in the readings. Typical failure points are in the corners where the wall meets the bath base and around the bath tap fixtures. It is recommended you constantly monitor these junctions to ensure damage is not occurring to the adjacent walls. The shower was tested. There was no visible indications of water penetration to surrounding areas. **IMPORTANT NOTE:** The test may not reveal water leaks until the system has been tested under normal or constant use. Shower wall linings are worn. Allow for future replacement.

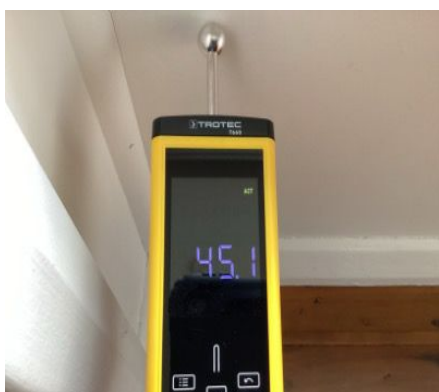
There are elevated readings, the exact reason for this cannot be determined and therefore requires further investigation. Due to the age and construction principles of this dwelling, a likely cause of this elevation could be due to the use of foil-backed wall linings. (Or similar ) Linings of this nature typically cause elevated readings. Please allow to read the council documentation to determine the lining type prior to engaging a weathertightness specialist.

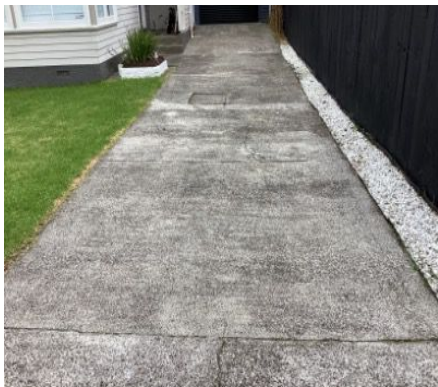
There is cracking in the driveway. This should remain serviceable for light passenger vehicle traffic.

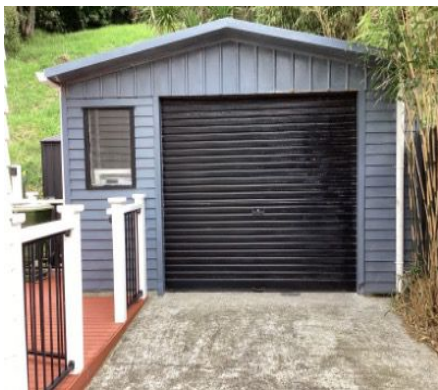
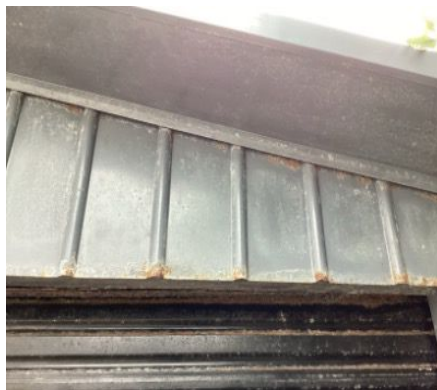
The garage is a proprietary garage. These are simple construction. All the building elements are bare minimum and are often cheaper products. Generally this garage is functioning as intended for the purposes of storing goods or a car, not for habitable spaces. Typically these garages have an increased amounts of maintenance due to there construction.

Cladding is corroded. Treatment and painting may extend the life of the cladding.

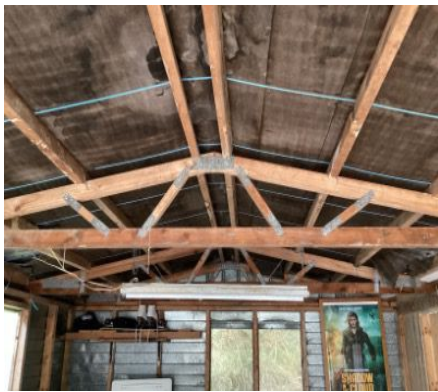
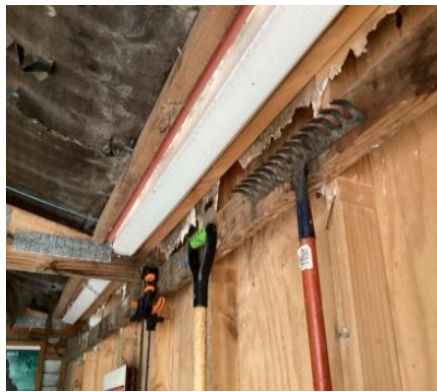
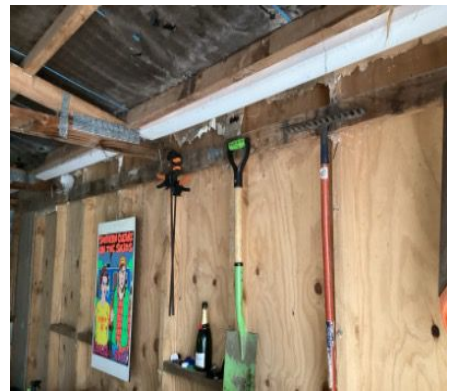
It appears that the original gutter has corroded and has been replaced. Plasterboard wall linings have been removed where they have been wet.

1. The PVC gutter installed to replace the original gutter, is not shaped correctly for the space, and may not capture all water, causing further water ingress. We recommend to replace with a purpose made gutter, made with a durable metal, or plywood and membrane, shaped to suit the roof.

2. The plasterboard wall linings that have now been removed, are part of the fire rating of this wall.

Linings will need to be reinstated to achieve the required fire rating. This is required, to prevent potential spread of fire to the neighbouring property.
